INDOOR AIR QUALITY ASSESSMENT

**Jacobs Elementary School
180 Harbor View Road
Hull, Massachusetts 02405**

Prepared by:
Massachusetts Department of Public Health
Center for Environmental Health
Emergency Response/Indoor Air Quality Program
October 2006

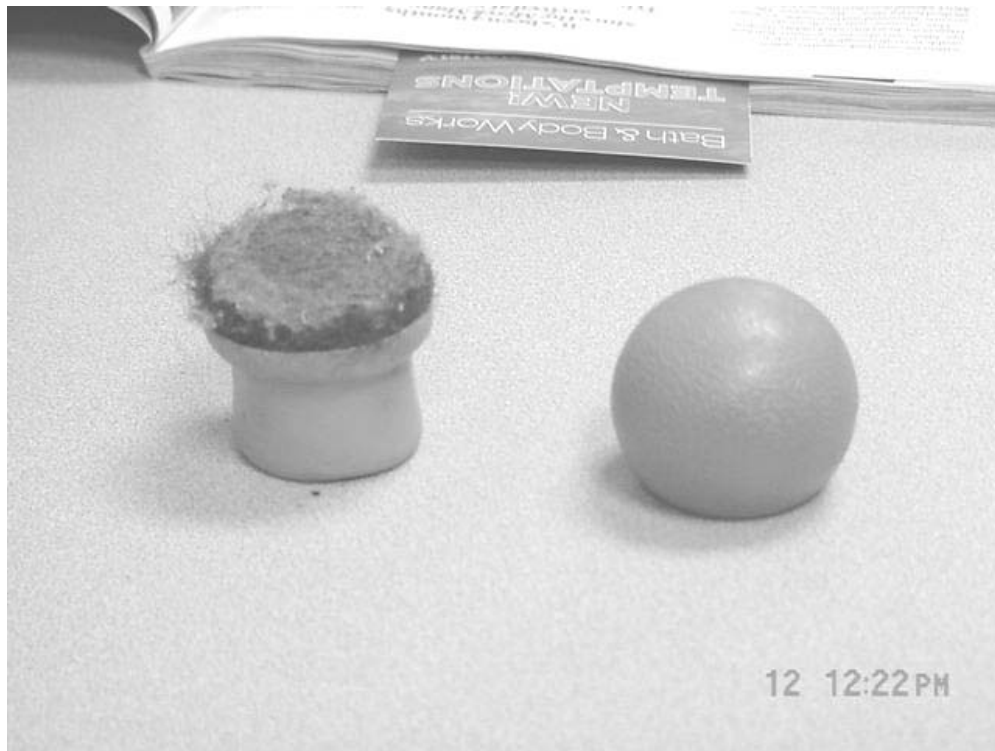
Picture 21

Alternative “glides” for chair legs that can be used in place of tennis balls

In an effort to reduce noise from sliding chairs, tennis balls had been sliced open and placed on chair legs in some areas (Picture 20). Tennis balls are made of a number of materials that are a source of respiratory irritants. Constant wearing of tennis balls can produce fibers and off gas VOCs. Tennis balls are made with a natural rubber latex bladder, which becomes abraded when used as a chair leg pad. Use of tennis balls in this manner may introduce latex dust into the school environment. Some individuals are highly allergic to latex (e.g., spina bifida patients) (SBAA, 2001). It is recommended that the use of materials containing latex be limited in buildings to reduce the likelihood of symptoms in sensitive individuals (NIOSH, 1997). A question and answer sheet concerning latex allergy is attached as Appendix B (NIOSH, 1998). Consider replacing tennis balls with alternative glides (Picture 21).

16. Consider discontinuing the use of tennis balls on furniture and replacing tennis balls with alternative “glides” as shown in Picture 21.
17. Develop a clear line of communication between the central maintenance department and school personnel for prompt remediation of temperature and/or ventilation concerns/complaints. This can be done by establishing a written request system (e.g., work order form) administered by a single responsible person see Appendix B as an example.

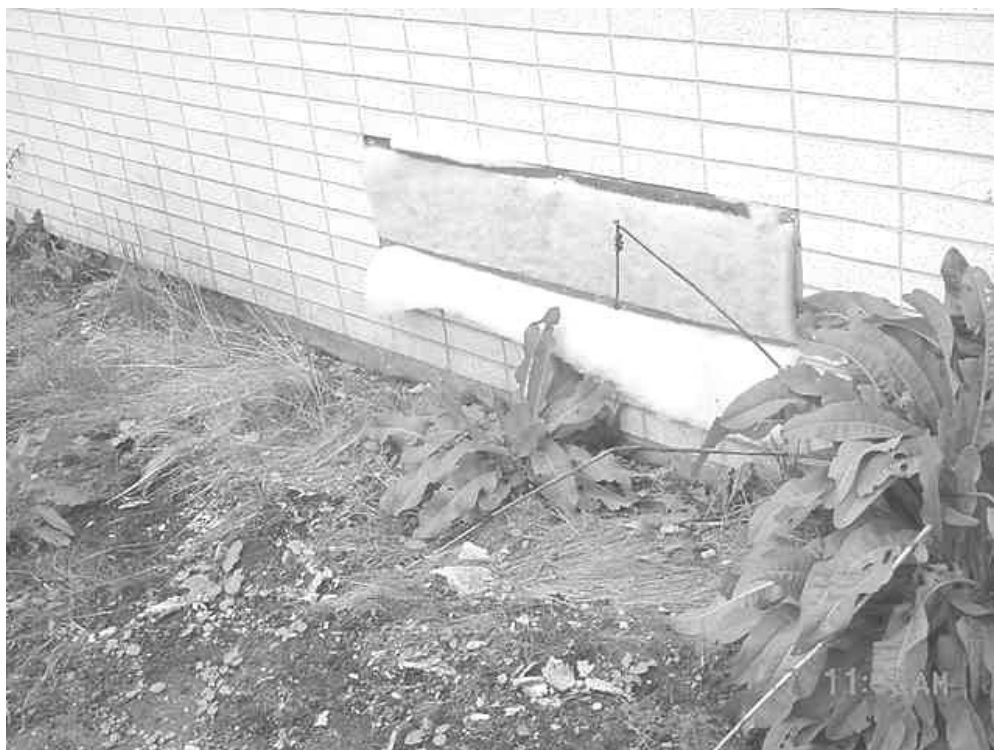
Picture 23

Univent Air Intake Covered with Filter Media, Picture Taken at Renovation/Construction Project at Wachusett Regional High School, Holden, MA

17. Consider installing filter media to the outside of air intakes as shown in Picture 23. Although this measure will decrease the entrainment of airborne particulates, it will also limit the introduction of outside air.
